Princeton's Double Lightning-struck Tulip Tree

Case Study In Strategic Tree Removal

By **Mark Chisholm**

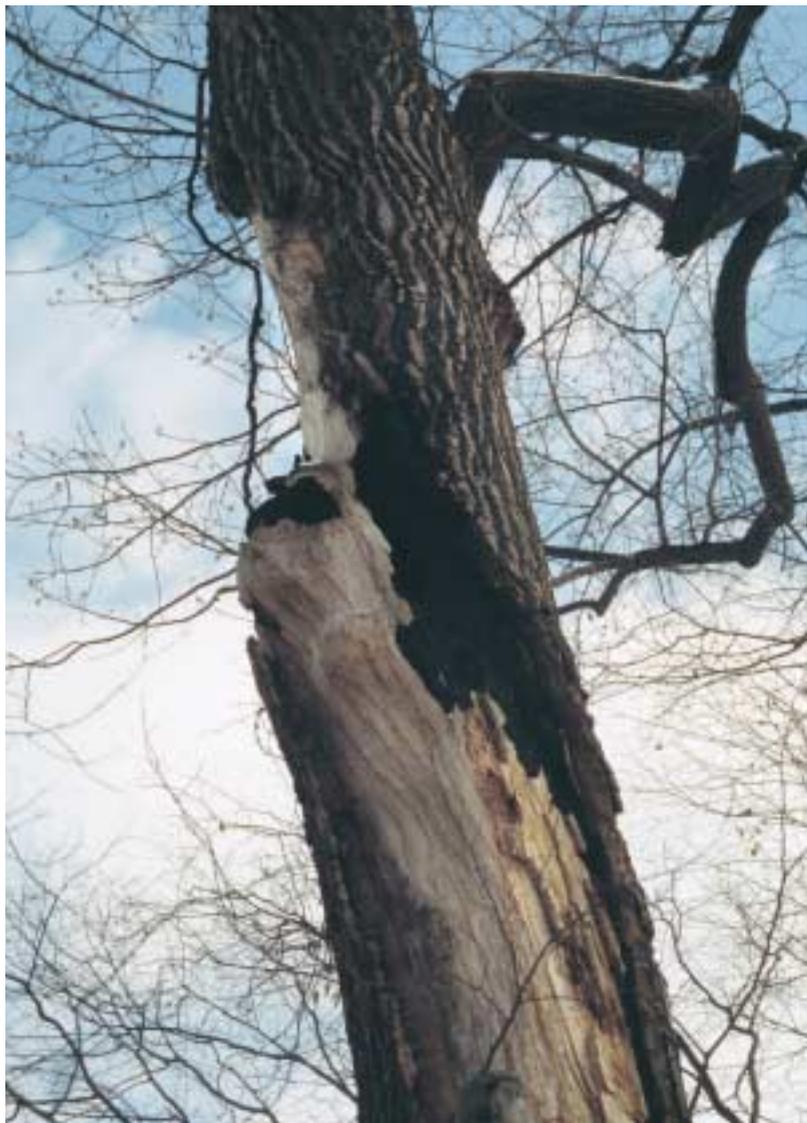
Above: The 130-foot-tall lightning-struck tulip tree suffered an advanced area of decay.
Above Right: An 80-ton capacity crane was utilized to remove the double-trunk tree, while a second crane secured Mark Chisholm to reduce the risk of injury.
Photos courtesy of Steve Chisholm

The tree had a double-trunk and was twice struck by lightning. The second strike resulted in fire, creating an advanced area of decay in the lower third of the tree. Located on the side of a small, winding two-lane road, the tree was more than 130 feet tall. Moreover, the larger of the double-trunks had a diameter of 56 inches and its smaller counterpart measured 48 inches. As if this wasn't challenging enough, electrical conductors ran alongside the tree and were within three feet of the trunk.
